# ADR COMPLIANCE SERVICES

## Report on Hoffman Group Helix Brand Aftermarket Steering Column

The Hoffman Group manufactures a tilt adjustable steering column to be used in modified vehicles. It has requested ADR Compliance Services to test the column to confirm its compliance with applicable standards and design rules and its suitability for use in modified vehicles.

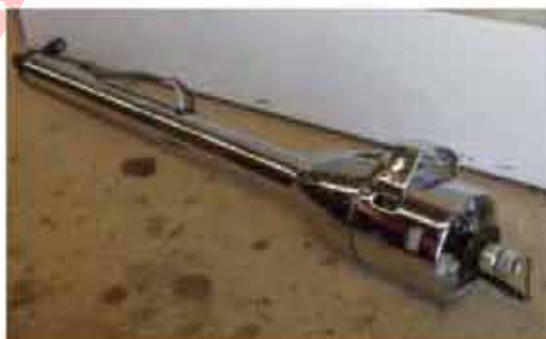
The Hoffman Group steering columns (part number STCOL1 tested) are not collapsible and are therefore only suitable for use in vehicles not required to comply with ADR 10/-. There are two versions available from the Hoffman group, one suitable for use with floor change and the other for column shift transmissions. In all respects relevant to this analysis the two versions are identical. In each case the external casing is chrome plated. They provide a tilt adjustment via a Cup and Pin type universal joint with a central self-lubricating polymer bush. The inner column that transmits steering effort is a 1" diameter double D shaft designed to mount to a steering box or rack via a suitable universal joint. The tilt mechanism provides five locking positions.

Hoffman tilt adjustable steering column

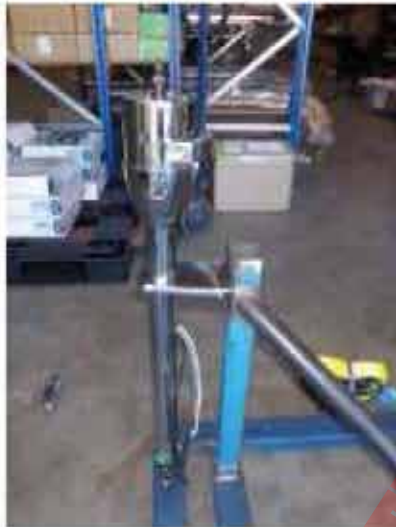
The jig supports the column to be tested and allows loads to be applied via a standard steering wheel adapter and a 500 mm long torque arm secured to the steering wheel adapter. A block and tackle allows sufficient force to be generated and a calibrated load cell records the load applied. It is noted that as the load is applied the effective torque arm becomes shorter through small elastic (and then plastic) rotation of the column. The effective length of the torque arm is measured at peak load to adjust for this.

Column installed in test jig

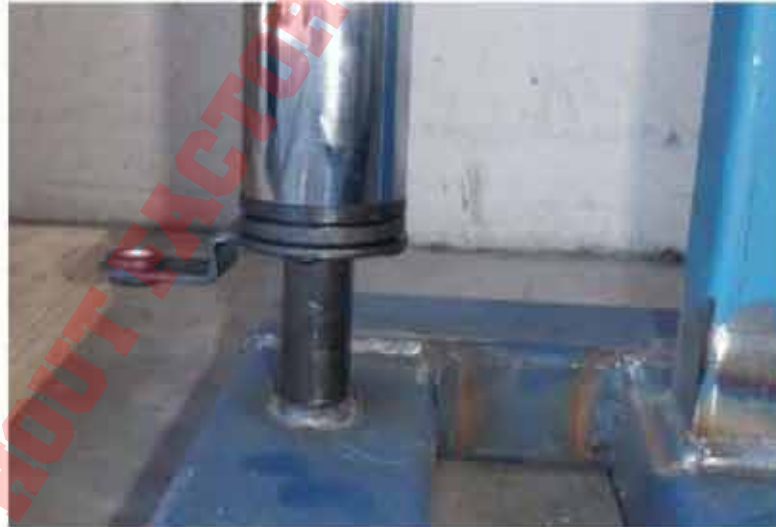
Detail of inner column locating spigot

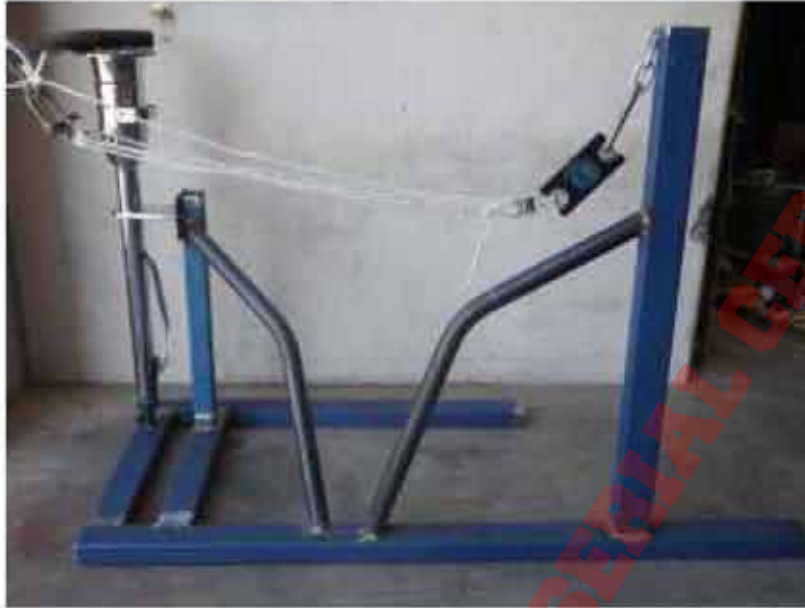
Immediately prior to test.

A 194Nm torque was applied to the column and no plastic deformation was observed. The applied torque was then gradually increased to 225Nm at which time some apparent plastic deformation was observed. When the load was released the column was measured to have twisted by 3.5 degrees from its starting position.

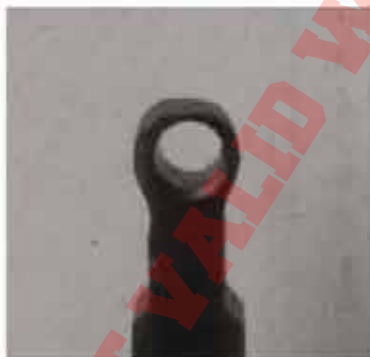
The lower shaft features an 8mm diameter hole through which passes the lower pin that mounts the polymer bush that in turn allows the tilt functionality of the steering column. The shaft is machined in this vicinity to provide clearance for the polymer bush to pivot. Examination of five Hoffman columns revealed some variation in the machining of this clearance.

Shaft Eye showing apparent irregular machining

A total of five lower column shafts were inspected and while some variation was noted in the thickness of the material around the eye this variation was relatively small. The thickness of the material was measured at seven points around the eye on five shafts. The variation from the mean recorded was between 1.6 and 6.5%. It was also noted that photographs of the shafts appear to exaggerate the differences in the shaft ends unless the relative positions of shaft and camera are identical. There is also some variation in the chamfers on the outside of the eye which appears to contribute to this effect.

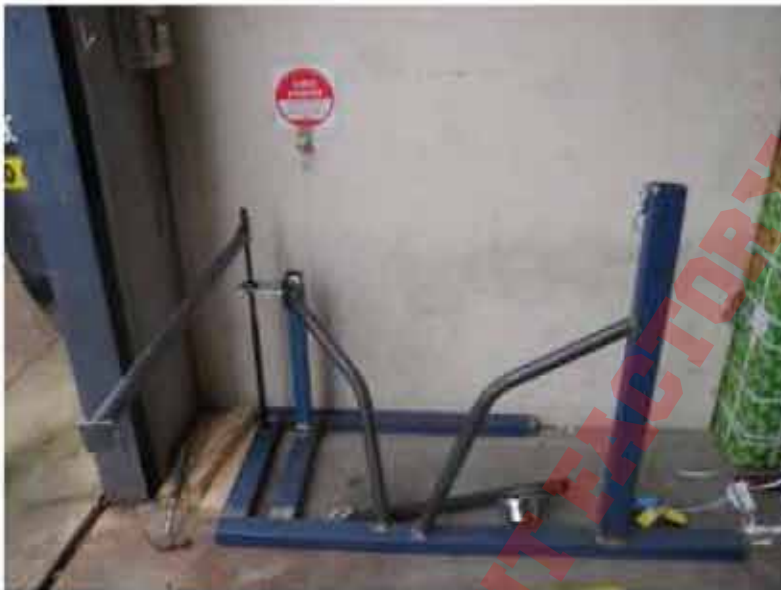
The robustness of the shaft ends was also tested by applying a similar test to that described in Section 1. Each of the five lower shafts and a genuine Ford item were installed in the test jig in turn and loaded through a revised torque arm until plastic deformation was observed.

Lower Shaft installed in test jig, note revised torque arm

Shaft	Yield Torque
1	210Nm
2	205Nm
3	200Nm
4	210Nm
5	195Nm
Ford OEM	225Nm

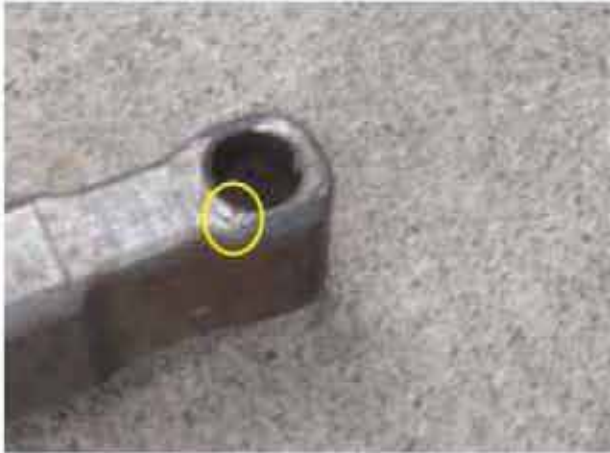
cracking that was observed was noted in the Ford column. No sudden failure was able to be induced. Indicating that steering would not be lost through a failure at any, practically possible, load level.

Ford Column post test (crack circled)

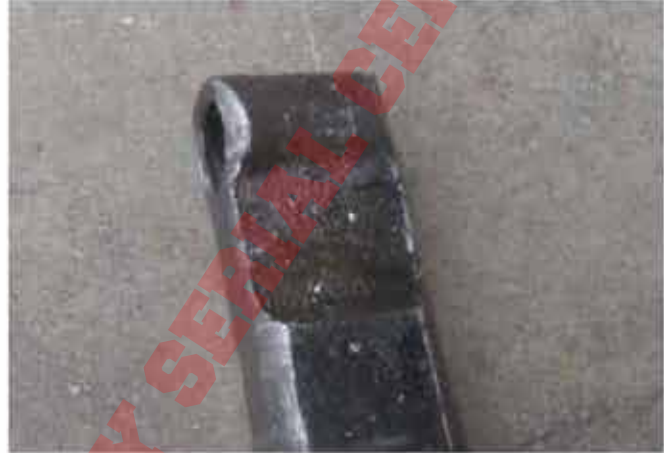
In the very unlikely event of an overload leading to plastic deformation, steering would not be lost. The damage would however be obvious to the driver as the steering wheel would be offset.

Hoffman Column post test (note twist)

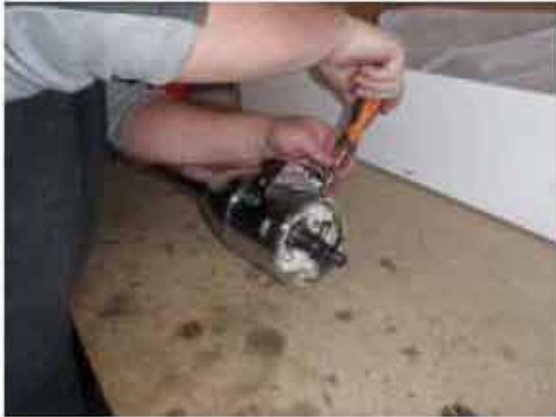
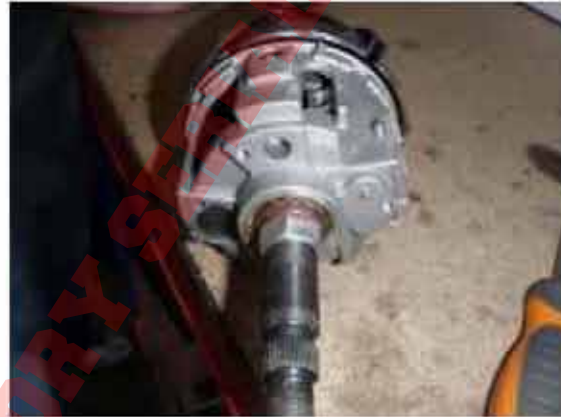
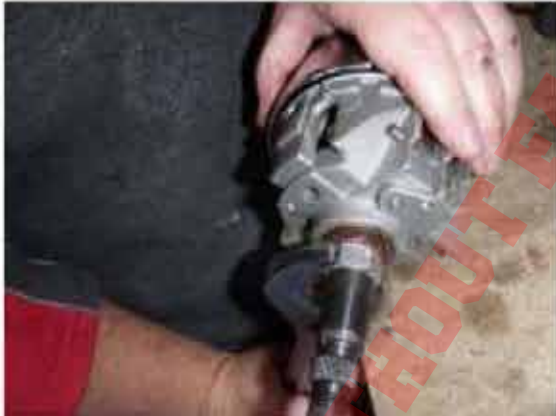
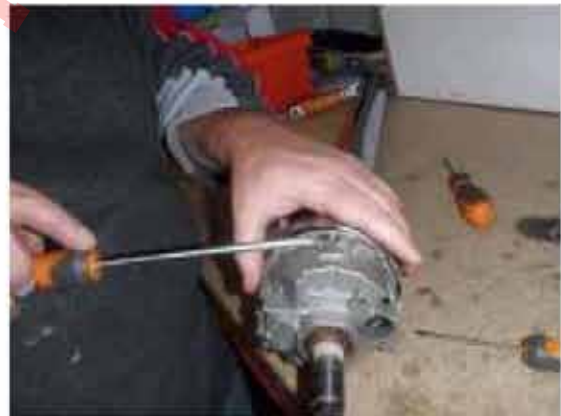
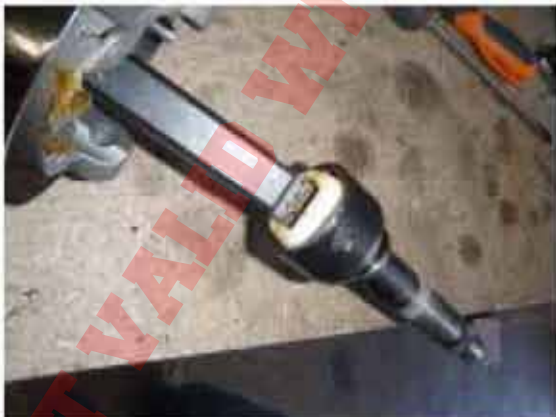
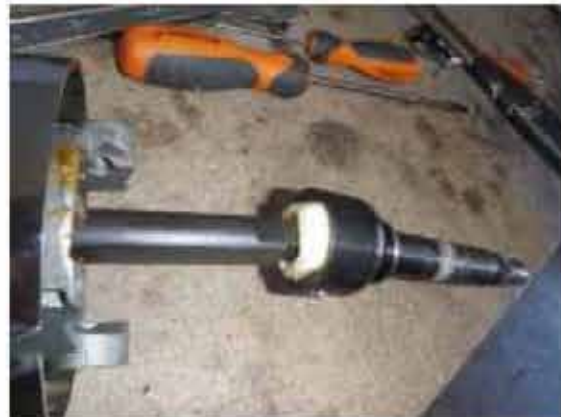
The Helix Brand steering column that had been torsionalloaded during testing was then stripped so that the universal joint that permits the tilt function could be examined along with the various pivot pins and the locking mechanism. The disassembly process was photographed.

No deformation of the polymer bush was observed.

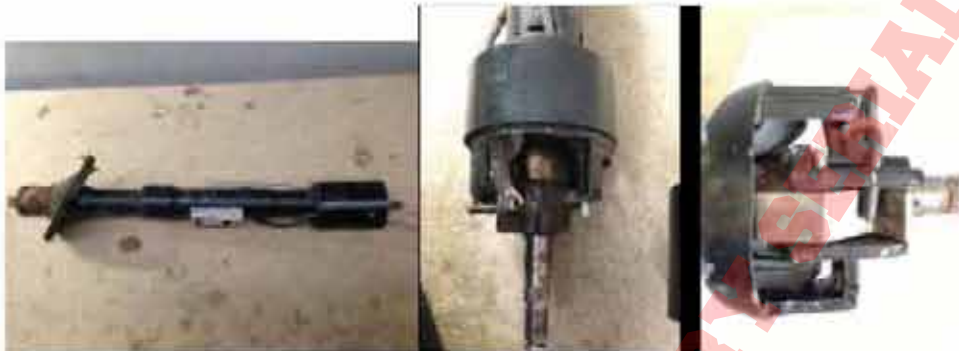
A used steering column from a 1985 forward F1 50 light truck was obtained from the USA. This unit was stripped so that the universal joint that provides the tilt function could be examined. The following photographs show the Ford column being disassembled and details of the universal joint that provides the tilt functionality.

Ford OEM Complete Column

Outer Cover removed

Locking Mechanism

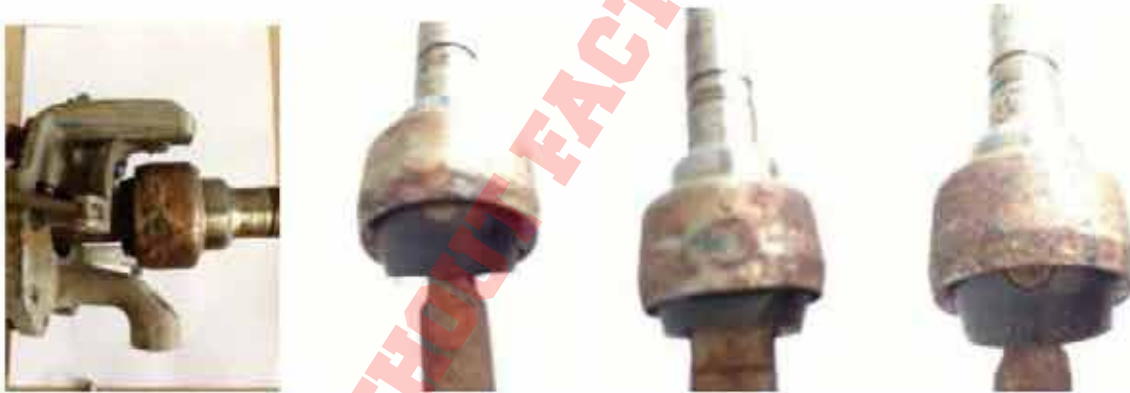
The polymer bushes from both the Ford and Hoffman group joints were removed and sent to ExcelPlas Polymer Technology for identification. (see appendix A.) They were found to be made from the same material Polyoxymethylene (Acetal) (POM).

Ford OEM Column Universal Joint Exposed, note polymer bush and pivot pins.

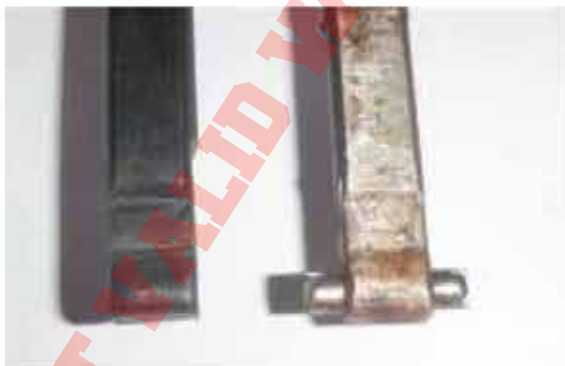
Ford OEM and Hoffman Group (left) Top end of lower columns.

The design of the Ford and Hoffman Group tilt adjustable steering column joints are effectively the same. Pins are the same diameter (8mm), the lower and upper shaft and the joint are similarly shaped. The polymer bush is similarly shaped and manufactured from the same material.

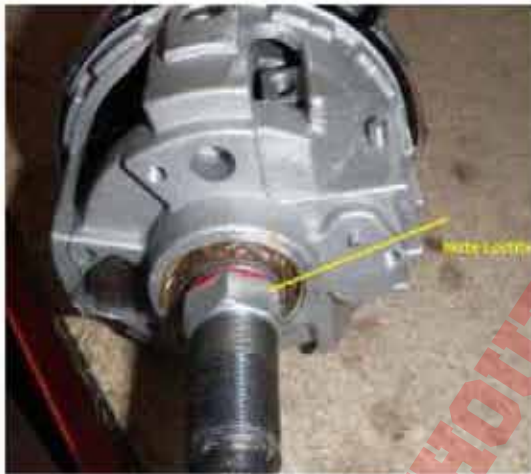
During the stripping of the Hoffman column it was observed that the securing nut had been secured with Loctite or a similar compound. The photographs below show the retaining compound evident before the nut was undone. The retaining compound residue is shown in the right-hand photograph. It was necessary to use a spanner to undo the nut along the entire length of the upper shaft, the retaining compound residue caused the thread to bind sufficiently such that the nut could not be undone without the use of tools.

Note Retaining Compound (red)

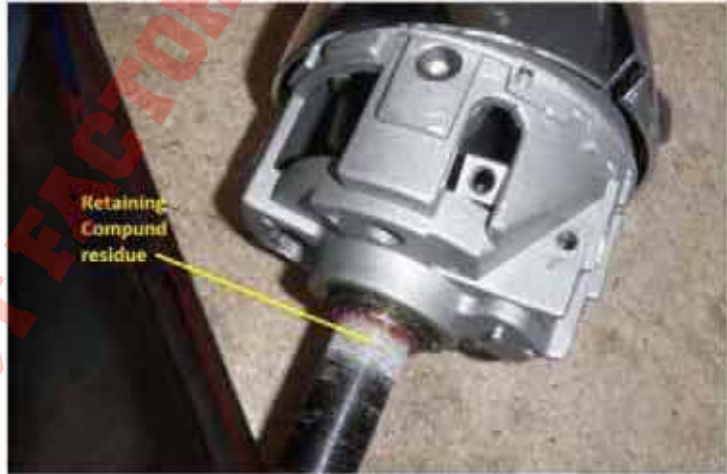
Retaining compound residue

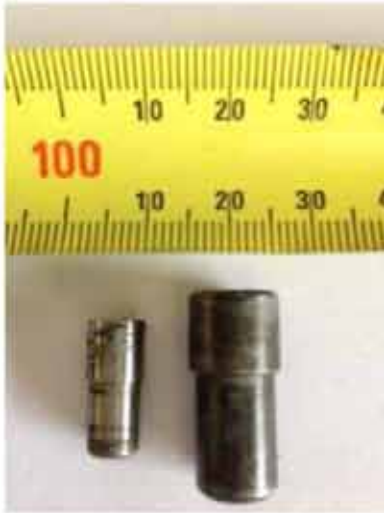
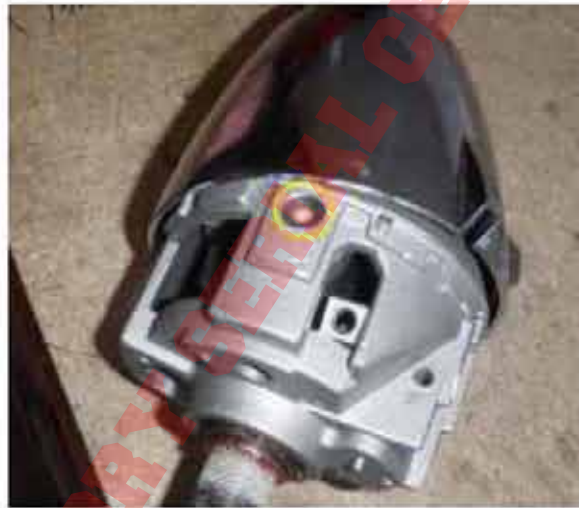
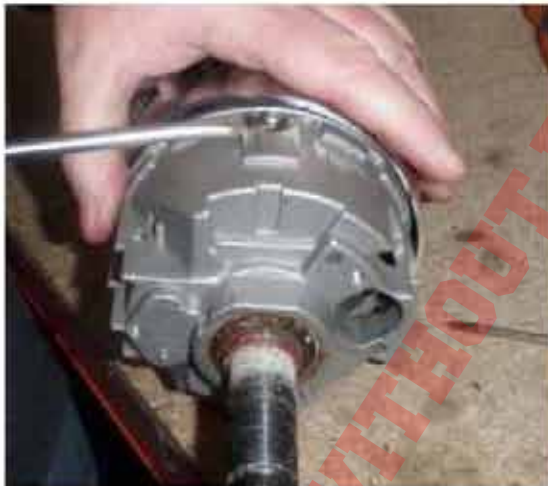
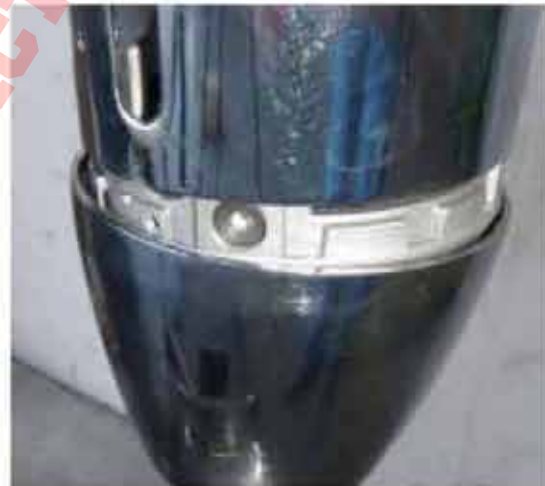
A pair of stepped pins are used to allow the Upper Housing and shaft to pivot relative to the lower column. The pins are a stepped design, the larger diameter was found to be a press fit into the Upper Housing. The photograph below shows the Hoffman pivot pin (right) with the equivalent Ford pin. Note the Ford item's smaller diameter and shorter length. The photograph to the right shows the Hoffman pin in position. The Hoffman pin is removed by screwing a pan head screw into the centre of the pin and using a screwdriver to lever it from the housing.

With the outer cover installed over the upper housing these pins could not be removed as the clearance between the top of the pin and the outer housing is less than 2mm. The pin needs to be extracted by approximately 8mm before the housing is released.

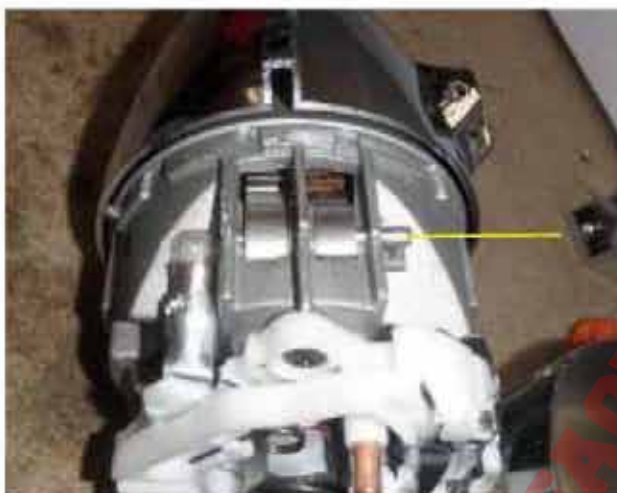
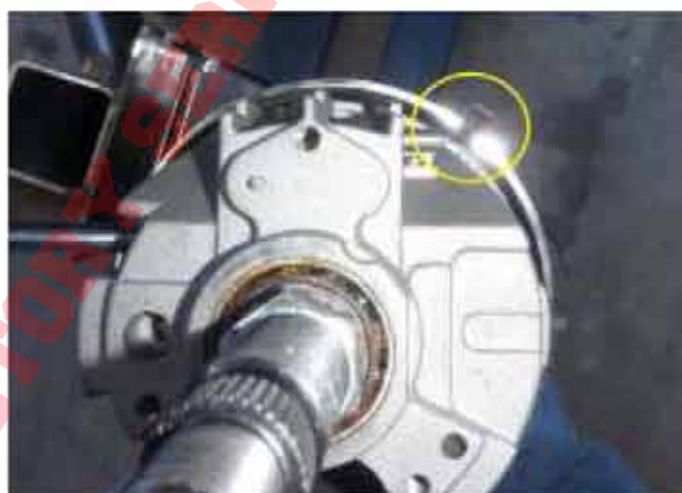
The tilt locking mechanism pivots on a long pivot pin, this is an easy interference fit in the upper housing. (see photograph) It can be removed with a pin punch and light hammering, it cannot be pushed from the housing without hammering. The pin is sufficiently long that it remains engaged at the required location relative to the housing even if it is driven as far as possible toward the outer cover.

With the outer cover in place the pin could not move sufficiently to allow the locking mechanism to disassemble. The end of the pivot pin would contact the inside of the cover before the pin became disengaged from the housing. The right-hand photograph below shows the pin in the position that it would contact the outer housing. The pin is still engaged in the left side of the housing. This is true also if the pin is driven in the opposite direction. The pivot pin cannot therefore work into a position that would allow the locking assembly to disassemble the cover is in place.

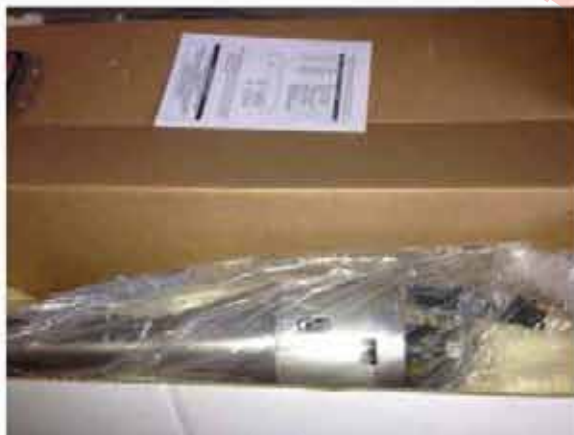
The same test as performed on the Hoffman brand column and described above in section 1 was performed on the Flaming River FR20001 tilting Steering column.

Flaming River Column

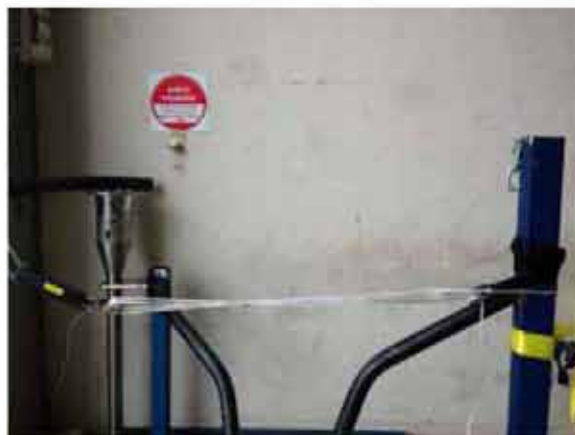
installed in jig, prior to test.

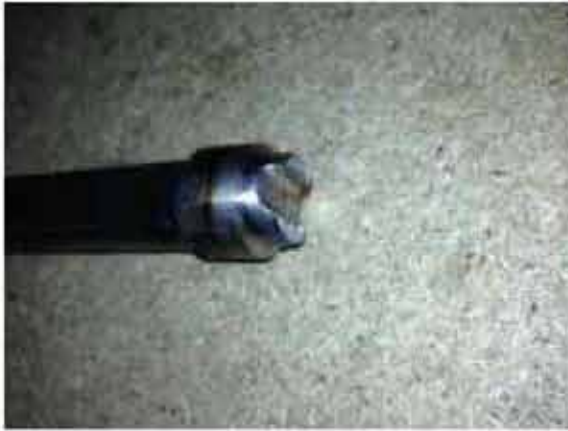
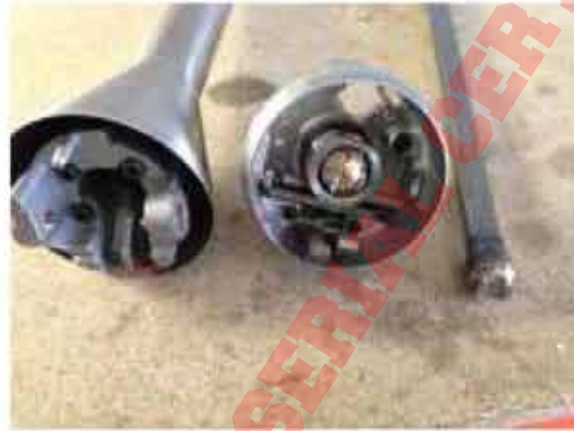
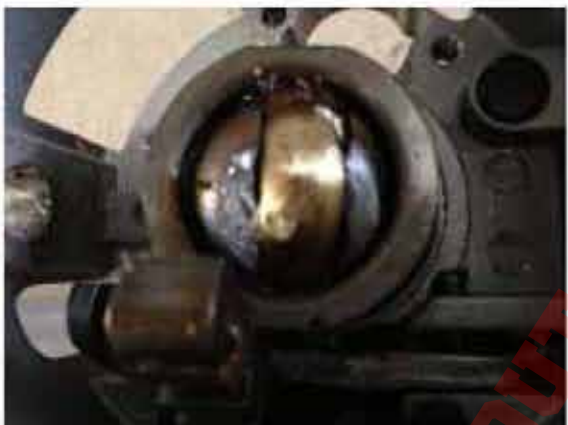
A torque of 154 Nm caused the Flaming River column to fail completely. All steering control would be lost if such a column were to fail in this way when installed in a vehicle. It is noted that this is

The column was stripped and it was found that the top portion of the steel lower shaft had failed.

Failed Flaming River Column

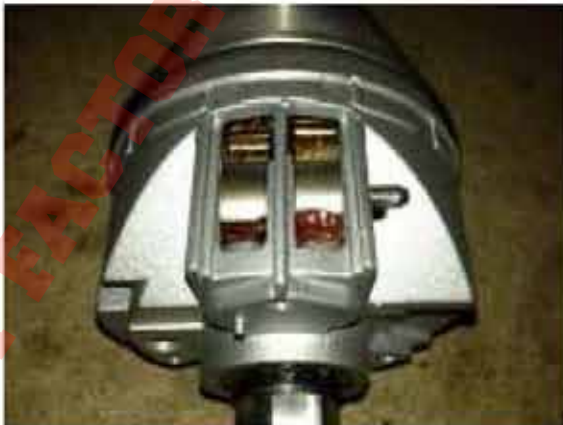
Note similar locking pivot pin arrangement to Hoffman Column
